## **MULL OF GALLOWAY TRAIL**

### **MULTI-USE NOTES**

The Mull of Galloway Trail is a 37 mile long-distance route, combining the Loch Ryan Coastal Path with a recently developed 24 mile path between Stranraer and the Mull of Galloway. The route was established and is mainly managed by Stranraer Rotary Club who, in conjunction with Dumfries and Galloway Council, have over the past few years replaced some of the former stiles with self-closing gates and developed new sections of path to reduce the length on road. Overall, the trail offers great variety in both scenery and walking experience, showcasing some of the best of the eastern Rhins, but was developed and is still promoted primarily as a walking route.

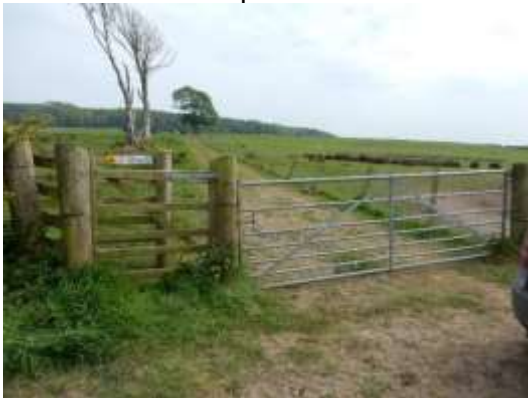
Location/ OS GR	Description
NX 081587	12' metal field gate (unlocked) with wooden kissing gate adjacent leads onto beaten earth track parallel to east side of fence.

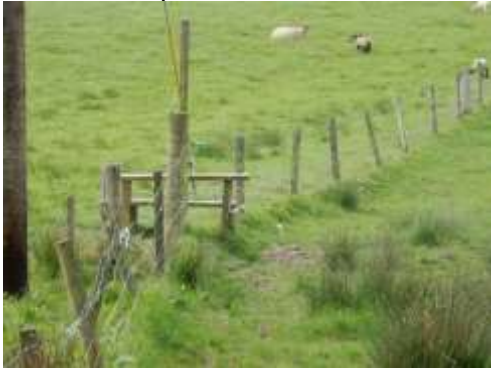
NX082586	Wooden step stile over rickety line wire and mesh fence provides alternative option on west side of fence when bull in field to east
NX084584	Wooden step stile over line wire and net fence connects back to main path.

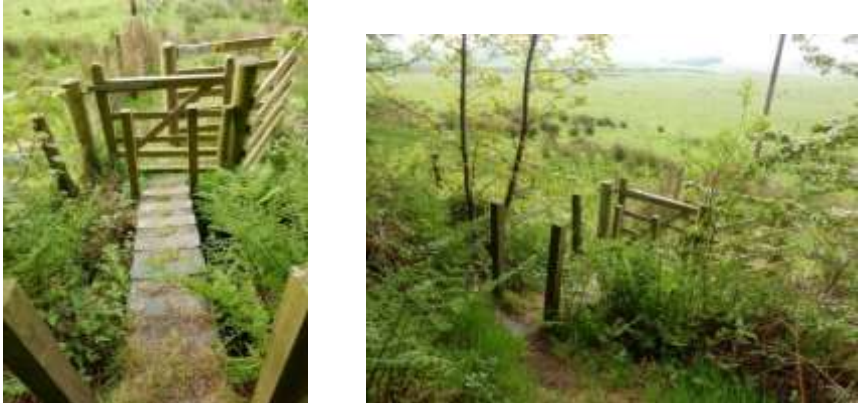
NX084583	Narrow wooden kissing gate in march fence with wood immediately followed by narrow wooden double sleeper bridge sloped at angle across relatively deep ditch. Narrow parallel wooden posts either end at south side of bridge. Impassable with a horse

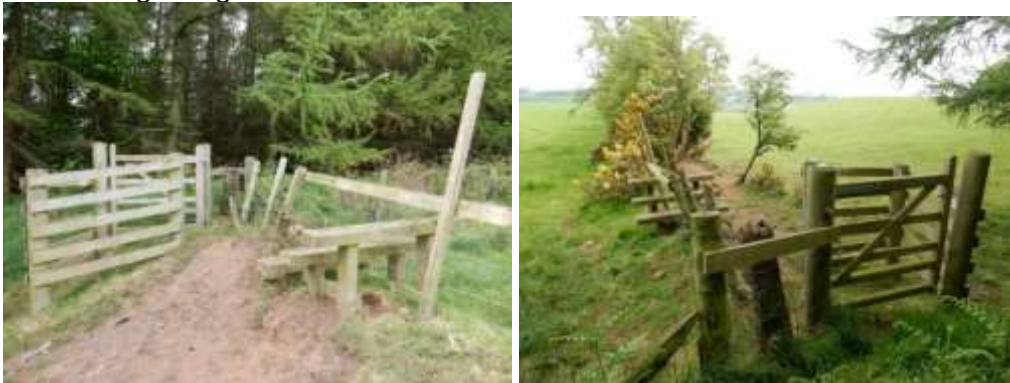
<p>NX084583</p>	<p>Wooden kissing gate in fenced boundary on south side of wood (no alternative), immediately followed by step stile over fence into adjacent field when bull grazing.</p>

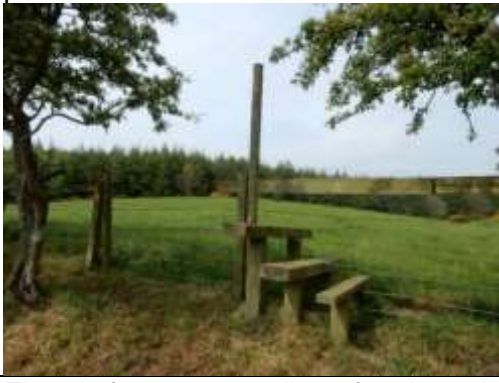
<p>NX085582</p>	<p>Wooden step stile over line wire fence provides access back onto main "path" west of fence. Barbed wire fence along south side of track to High Boreland prevents continuation east of fence if bull in field to west.</p>

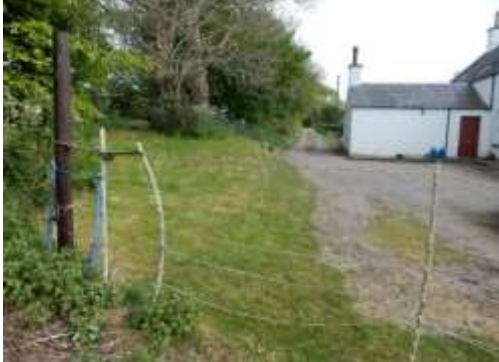
<p>NX087578</p>	<p>Electric fence across line of path enclosing horses. No alternative access other than electric fence post which slides to side, looped on rope</p>

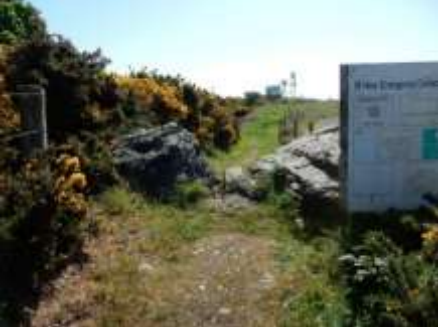
Location/OSGR	Description
NX111527	<p>Rock outcrop/boulders in line of path</p>

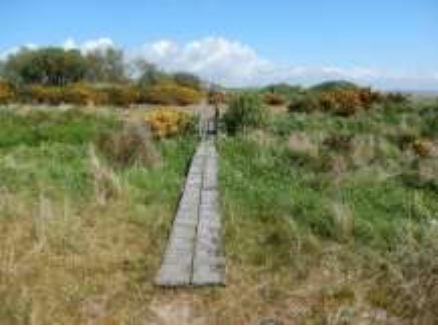
NX113522	<p>Metal 46 cm wide footbridge across Culmore Burn with metal mesh side panels and long extension boardwalk impassable with a horse. It may be possible to avoid the bridge along the beach at low tide but links between the path and beach were not surveyed</p>

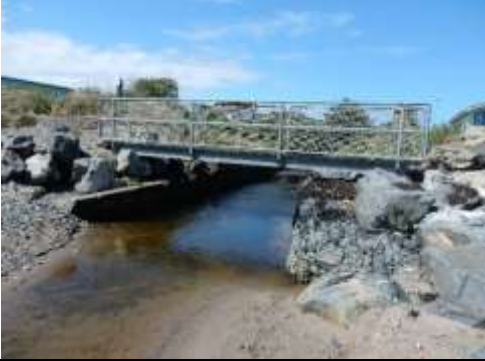
NX103508	<p>Narrow 46 cm footbridge impassable with a horse. Burn splays out below bridge so other than at high tide, easily crossed on beach.</p>

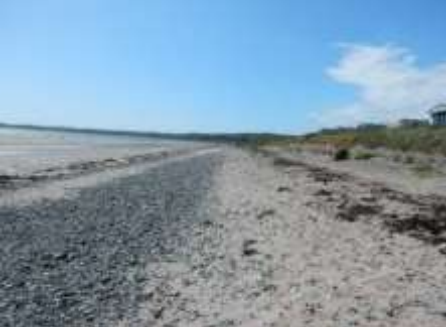
Sandhead north to Carisbrooke	<p>Promoted route follows foreshore, inaccessible at high tide. Mobile homes in holiday park come to edge of beach.</p>

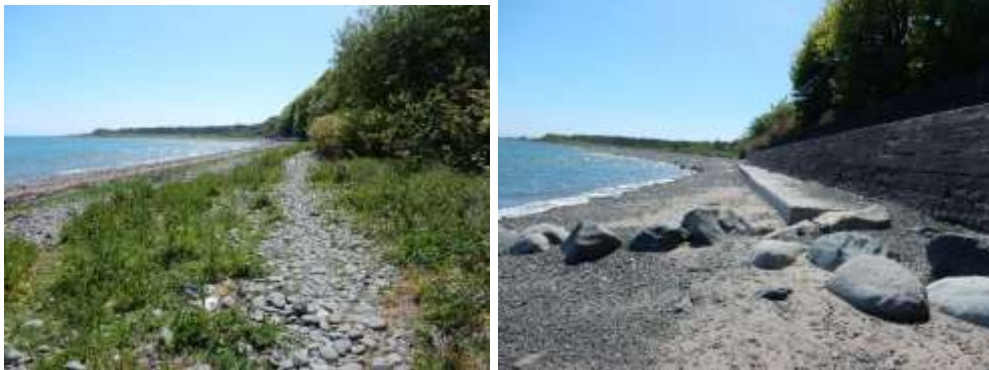
Main route follows foreshore below breakwater, impassable beyond mid-tide level.

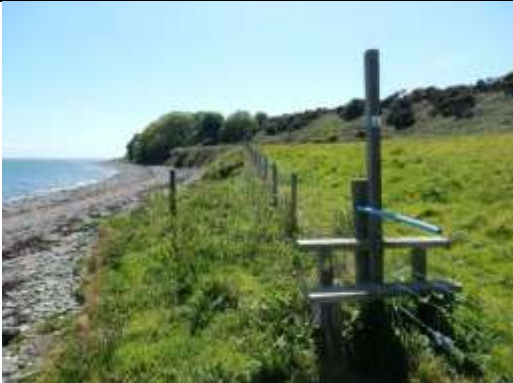
Location/OSGR	Description
Sandhead to Shore Cottages	Beaten earth path between parallel fences, narrow in places  
NX103488 Burn north of Shore Cottages	Narrow metal footbridge over Cairnwell Burn. Can be avoided along beach at low tide.  
Purdie's Point NX105486	Path re-routed due to cliff collapse during winter storms 2015. Path now crosses stocknet and barbed wire fence by wooden stile, no alternative.

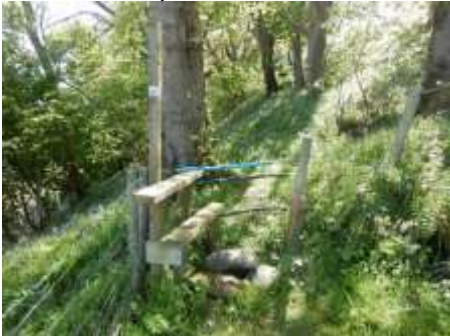
NX185404	<p>Wooden step stile over fence into wood, no alternative.</p>

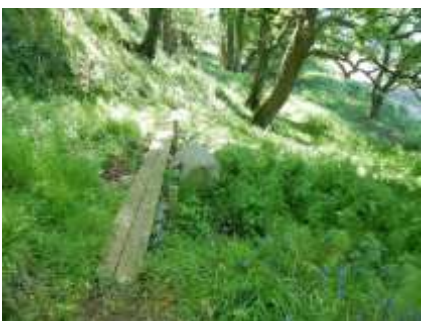
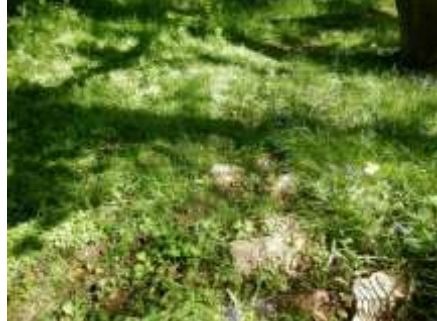
Wood east of Mull Hill	<p>Double wooden planks across burn, broken paving slab path continues downhill as steps. Unsuitable for multi-use</p>

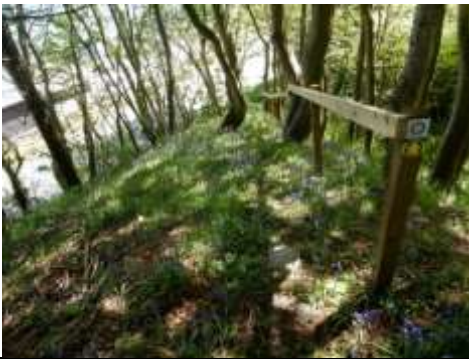
Alwhibbie Glen NX105475	<p>Narrow indistinct path through wood with low branches and easily disturbed ground unsuitable for multi-use. Broken paving slab steps with wooden handrail on lower side lead down to road</p>

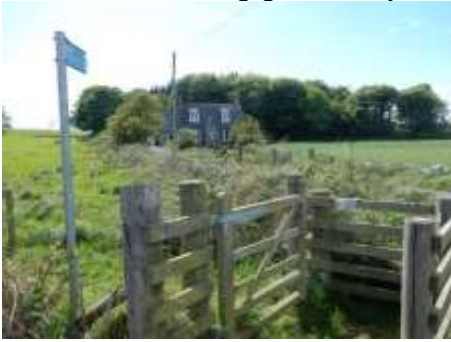
Location/OS GR	Description
NX108452 Chapel Rossan track end	<p>Wooden kissing gate off road onto newly fenced path along field headland. Self-closing 1.5 m gate at southern end of track but no alternative to kissing gate. Only other option is to use road</p>

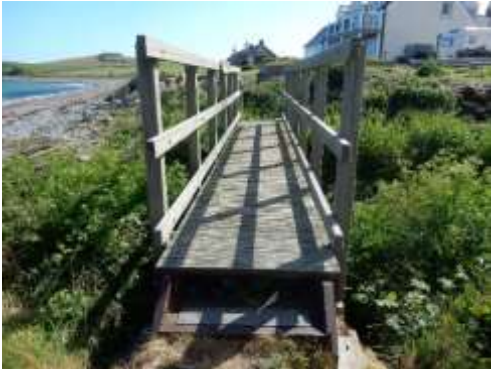
<p>NX116435</p>	<p>Wooden footbridge over Balkelzie Burn. 90 cm wide. 1 step north end, 2 steps south end. It may be possible to ford the burn on the beach at low tide</p>

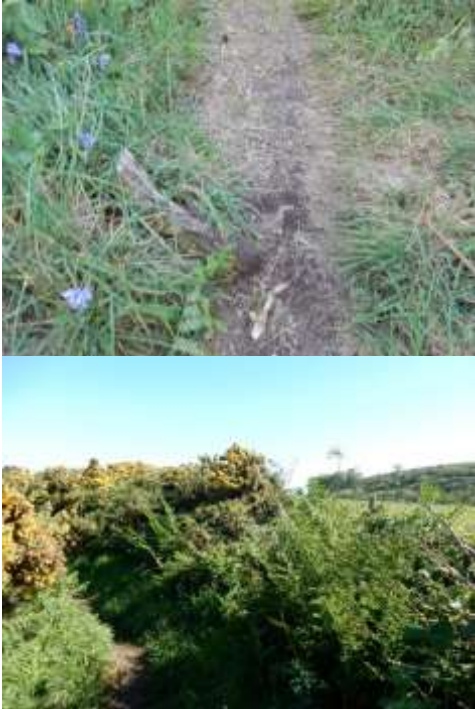
<p>Logan Mills to Balgowan Point</p>	<p>Clearly defined beaten earth path runs parallel to coastal side of dyke. Uneven underfoot, remains of cut gorse stems in line of path may be concealed by grass. Gorse restricts path width in places.</p>

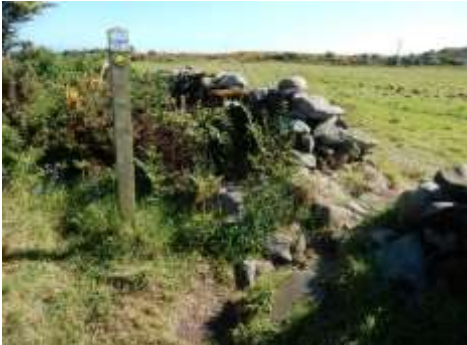
<p>NX122428 north of Balgowan Point</p>	<p>Wooden waymark post signs re-routed path over remains of dyke onto landward side avoiding cliff collapse to south. Path beyond passable with care.</p>

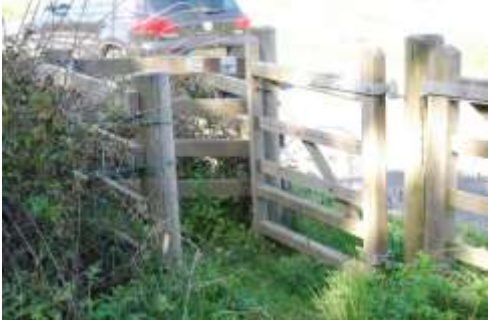
Location/OSGR	Description
NX126403 north end of Grennan Plantation	<p>Wooden kissing gate across new path along edge of wood west of road, adjacent 12' wooden field gate unlocked at time of survey.</p>

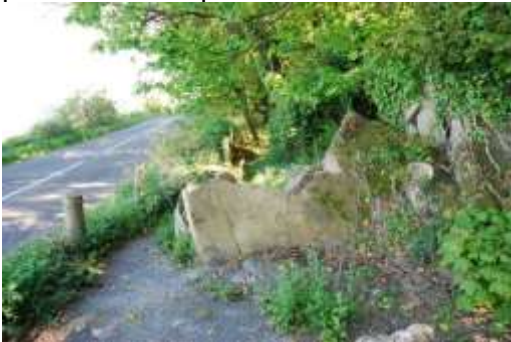
Grennan Plantation	<p>Narrow unsurfaced informal path winds along edge of wood parallel to road below rocky crags. Shallow informal steps in places, path supported by sections of birch trunk. Stone outcrop restricts width of path in several places</p>

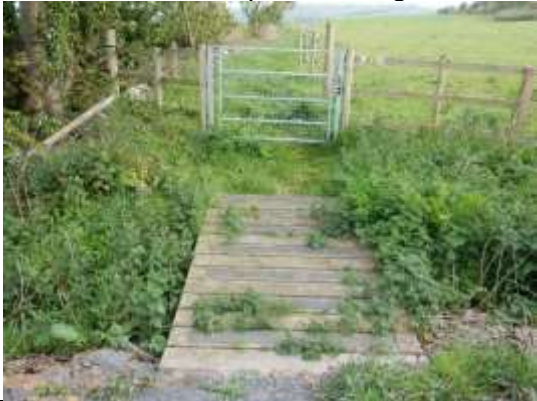
<p>NX127395</p>	<p>Wooden slatted bridge with non-slip strips across ditch in line of whindust surfaced path leading to one-way self-closing metal bridlegate</p>

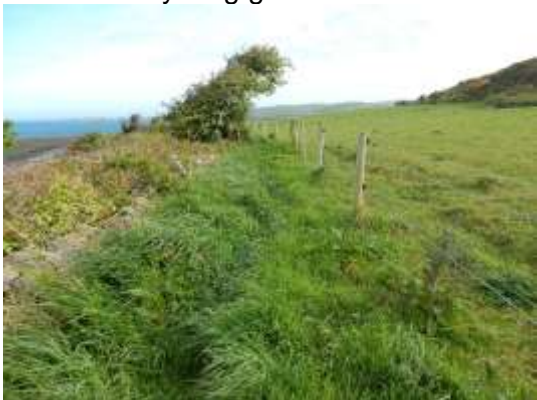
<p>Grennan quarry road to Kilstay Bay</p>	<p>Newly created path parallel to road inside field fenced to inside with electrified linewire on inside. Uneven surface/rocks in line of path concealed by long grass</p>

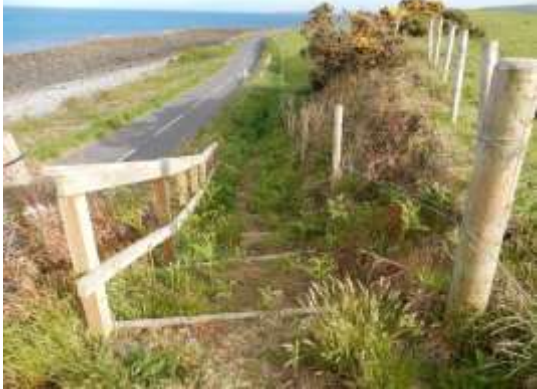
<p>Shallow wooden steps passable with care</p>

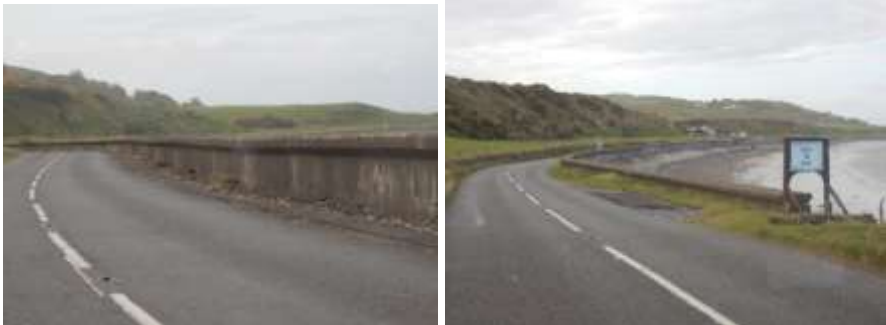
<p>Self-closing 1.5 m gate across southern end of path</p>
<p>Kilstay Bay - Drummore</p>	<p>Path along road, very narrow pavement for part way tight along sea wall, then rough narrow verge to end of sea wall.</p>

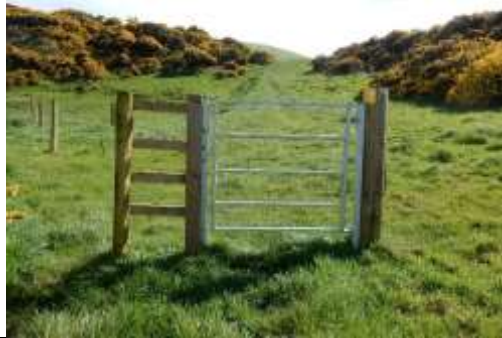
NX141324	<p>New metal bridlegate in fence onto hill</p>

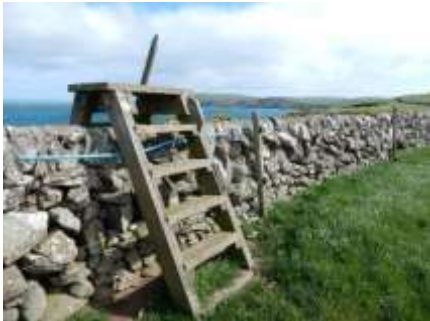
NX143320	<p>Steep wooden ladder stile over dyke where path passes back onto coastal side. Path continues on coastal side of dyke</p>

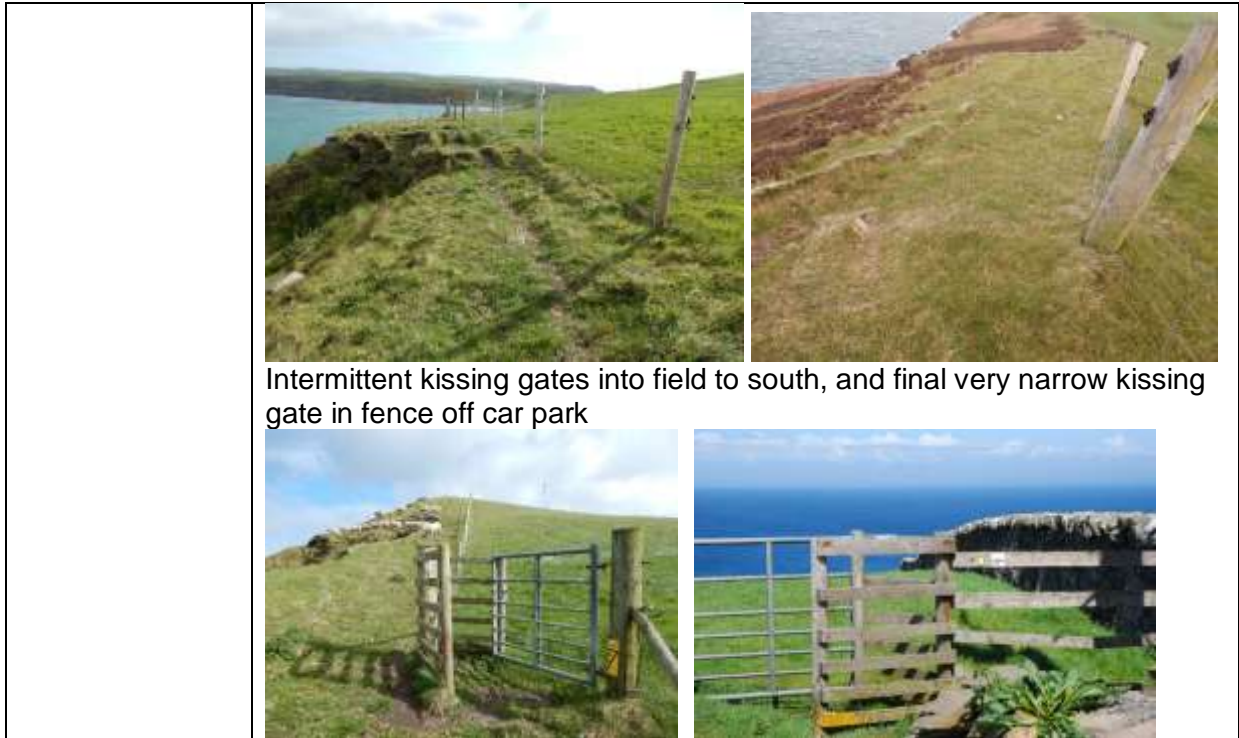
NX143312	<p>Metal bridlegate with metal fieldgate adjacent across end of track leading up to Youchtrie Heugh</p>  
East Tarbet to Mull of Galloway	<p>Route south remains on coastal side of fence, very narrow in places with metal stay wires across "path" at straining posts.</p>
